# Repair of Fiber Reinforced Thermoplastic Composite Panels

**Katie Blyler, Aerospace Engineering - Penn State University**  
**Advisor: Callie Zawaski and Greg Dillon**  
**Collaborators: Clark Moose, Vincent Torres, Matt Waller, Eric Strauch, and Xiaoshi Zhang**

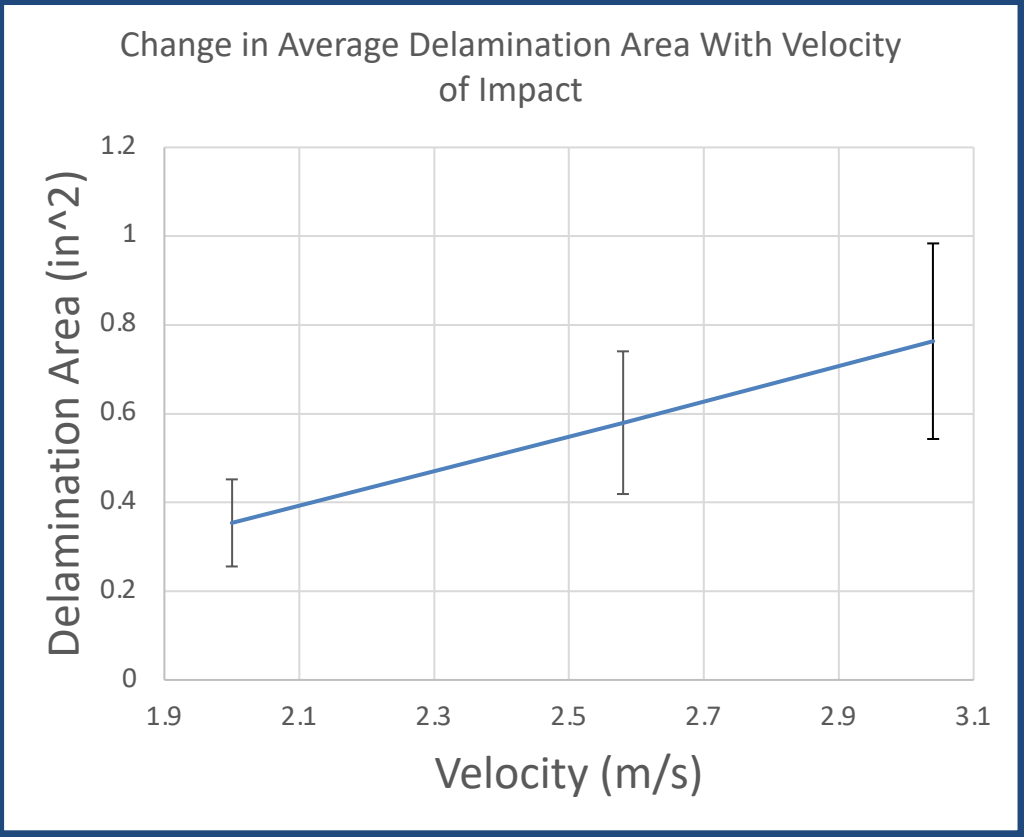
**Change in Avg. Delamination Area**

Visually, a difference in impact size could be seen as the impact velocity was increased. The impact was the only damage that could be seen visually. However, the ultrasonic scanning showed the delamination area was greater than what could be observed with the naked eye. The size of the delamination area increased linearly with an increase in the impact velocity.

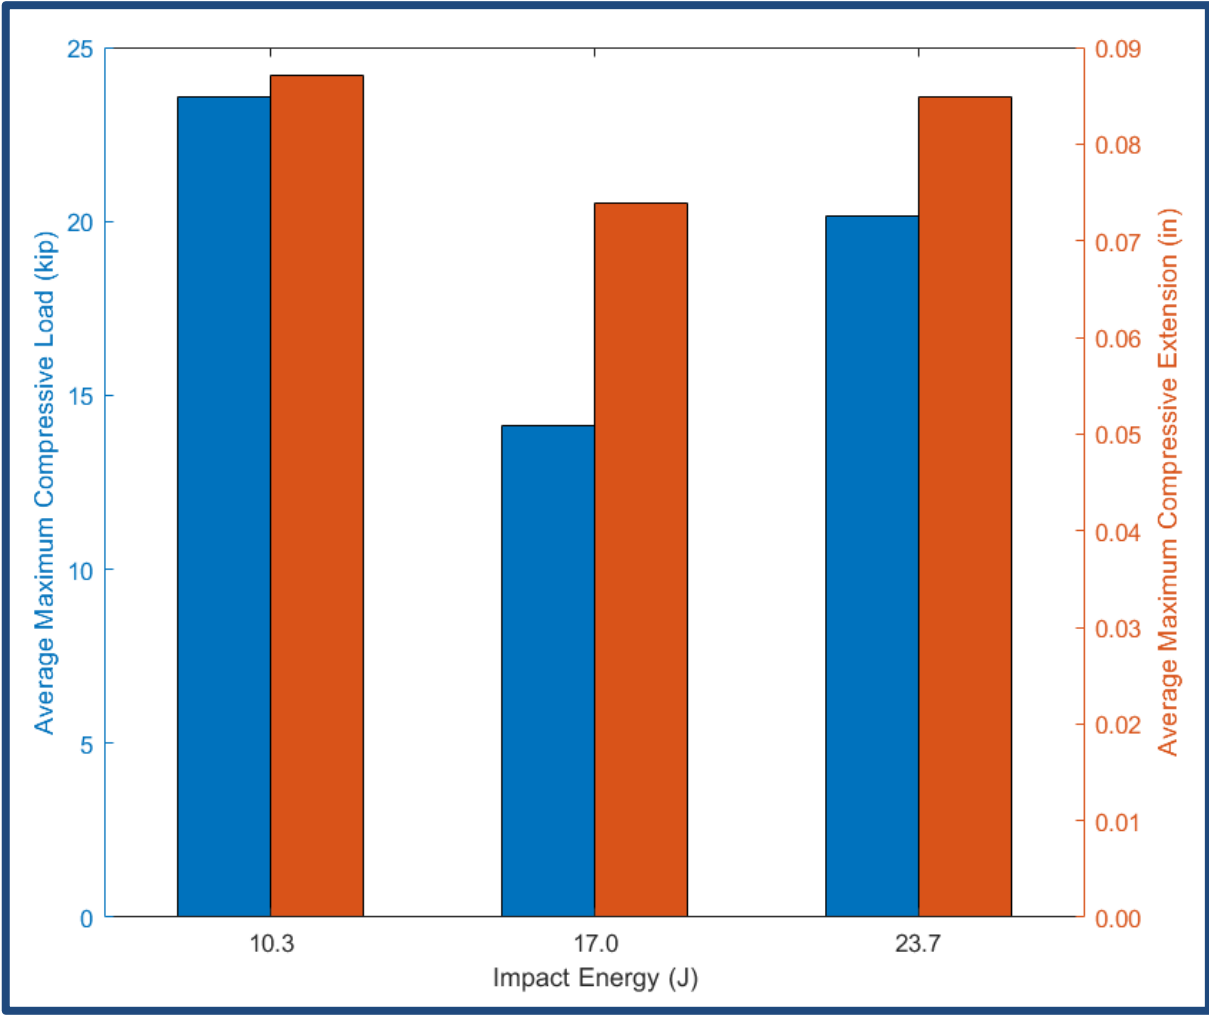
**CAI: Compressive Load vs. Compressive Extension**

The compression after impact (CAI) testing revealed that the 10.3 J energy level failed away from the impact location and demonstrated greater resistance to compressive loads. Comparatively, the 17.0 J and 23.7 J failed through the impact, with the 17.0 J panels failing at lower compressive loads. The 23.7 J panels however had a varied response to CAI due to failing with different modes at different compressive loads.

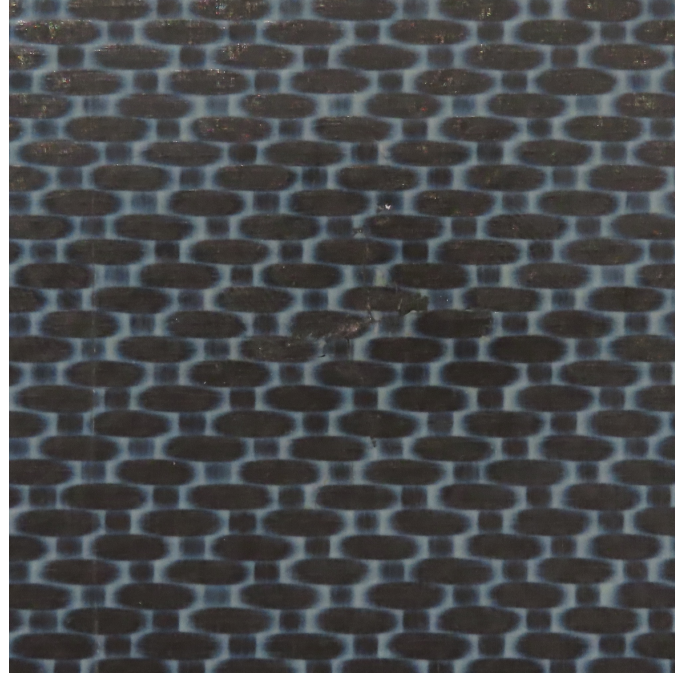
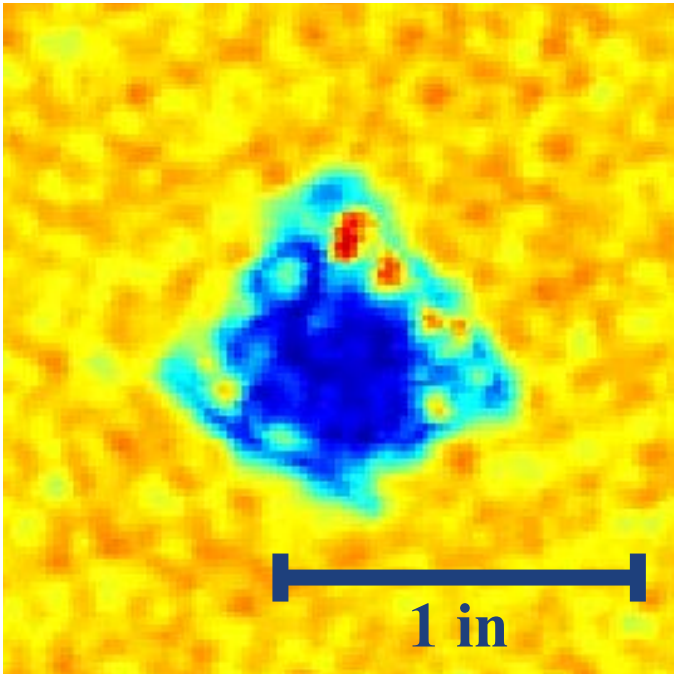
**After Repair**

The mould press was able to melt the surface of the panel and reform the shape to a flat panel similar to the original undamaged panel. Fiber breakage was still visible after repair.
